# PEDESTRIAN STUDY

MACON-BIBB COUNTY  
CRASH360 PROFILE & REPORT

**Annual Study  
2023**

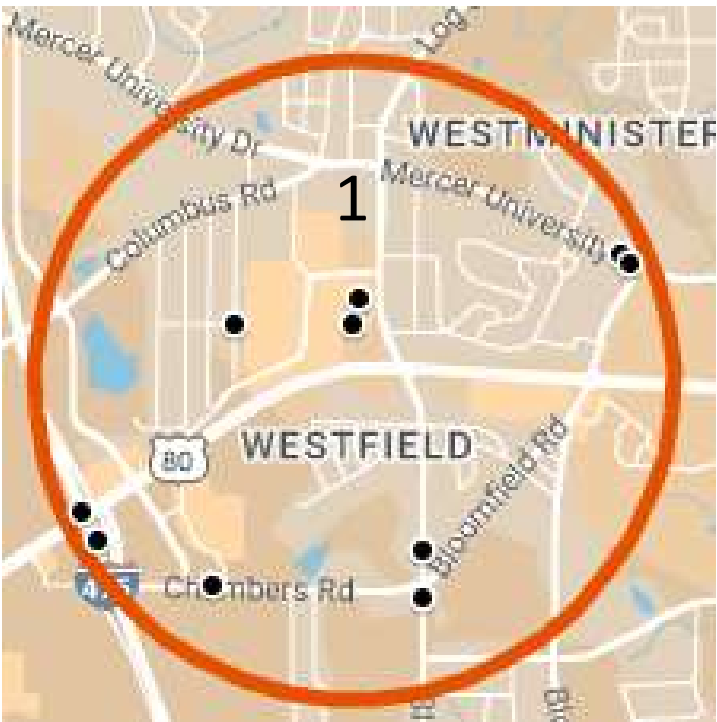
## LOCATION

This location is centered around the intersection of Eisenhower Pkwy and Log Cabin Drive. These crash locations are shown in the figure to the right. Ten crashes were studied in this zone.

- 60% of crashes occur on State Maintained Roadways
- 90% of crashes occur between noon and midnight

- Due to the quantity of crashes along a stretch of SR74 (from this study and previous), the following recommendations are provided.
- 1) Investigate status of existing street lighting along SR74 from the intersection of Atwood Drive down to the intersection of Bloomfield Road.
- 2) Consider lighted crosswalks or RRFBs.
- 3) Perform foot traffic study to evaluate where pedestrians are crossing 74 for consideration of the installation of additional crosswalks in or near areas where pedestrians are crossing naturally.

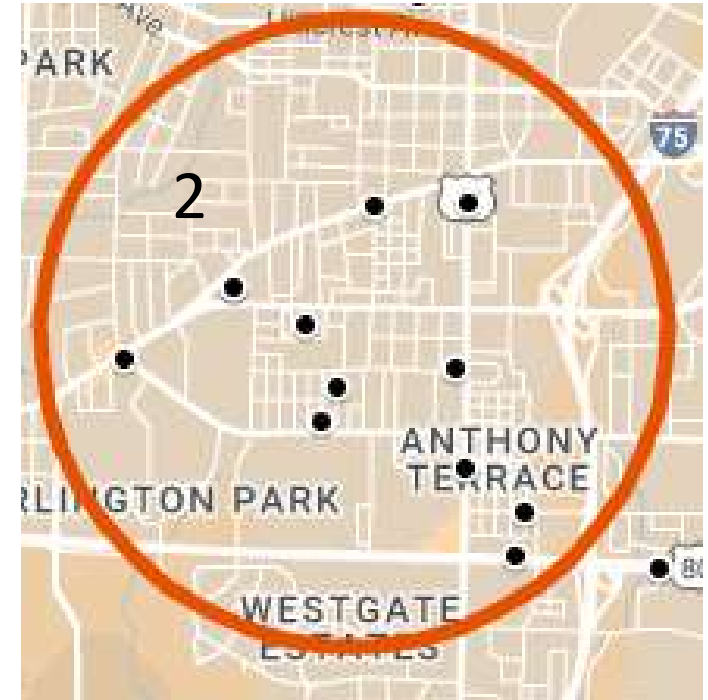
## LOCATION

This location is centered around the intersection of Mercy University Blvd and Pansy Drive. crash locations are shown in the figure to the right. Eleven crashes were studied in this zone.

State Road  
**36%**

City Road  
**64%**

- 64% of crashes occur on local roadways
- 82% of crashes occur between noon and midnight

- Numerous issues are in a Residential area with no sidewalks.
  - Install motion sensing street lights in the area around Grosso Ave and Lilly Ave.
- Consider evaluating street lighting in the area of Sapp St and Moseley Ave.

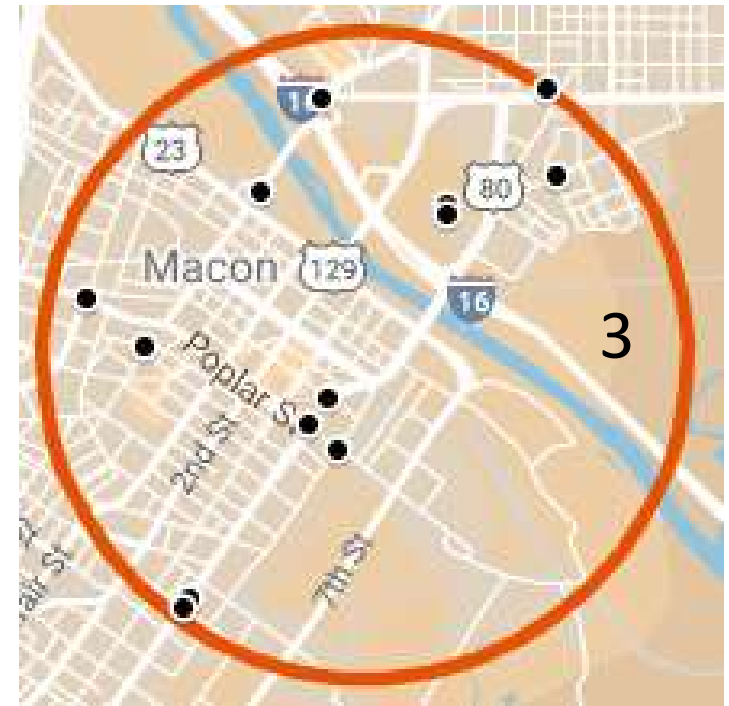
## LOCATION

This location is centered around the intersection of Broadway and Walnut Street. All crash locations are shown in the figure to the right. Thirteen crashes were studied in this zone.

State Road  
46%

City Road  
54%

- 75% of crashes occur on roadways
- 62% of crashes occur between noon and midnight

- Martin Luther King Jr. Blvd
  - Consider lighted crosswalks
  - Install motion sensing LED street lighting
  - Perform foot traffic study to ascertain where pedestrians are normally crossing between Cherry Street and Poplar Street
